MASH EVALUATION OF TXDOT ROADSIDE SAFETY FEATURES —PHASE II

Test Report 0-6946-R2

TEXAS A&M TRANSPORTATION INSTITUTE COLLEGE STATION, TEXAS

TEXAS DEPARTMENT OF TRANSPORTATION

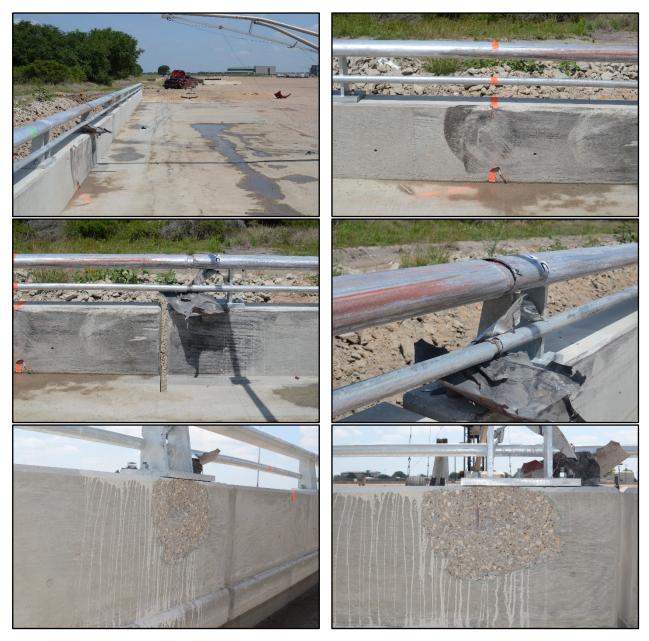
Figure 2.12. TxDOT C402 Bridge Rail after Test No. 469468-1-2.

Figure 2.12 shows the damage to the TxDOT C402 bridge rail. There was minimal deflection of the lower steel pedestrian rail and some concrete surface spalling on the field side of post 9. Working width was 16.5 inches, and the height of maximum working width was 46.0 inches. Maximum dynamic deflection was 1.1 inches, and no permanent deformation was observed in the metal rail elements.

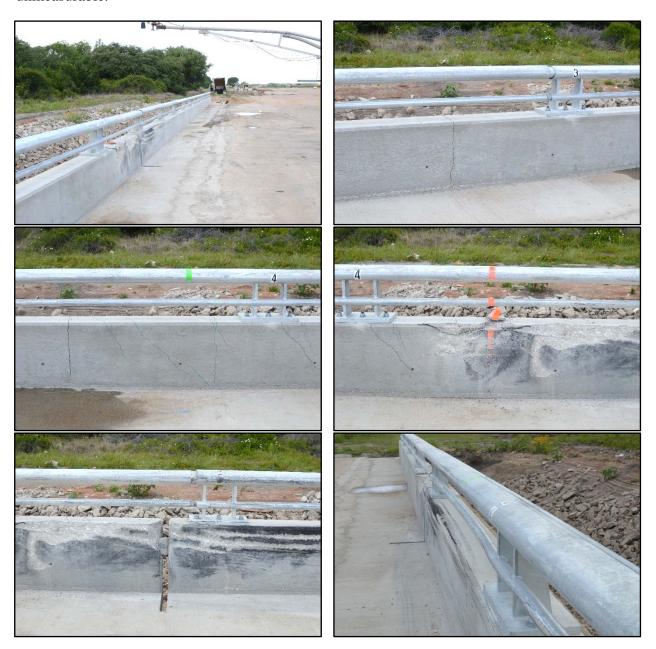
Figure 2.18. TxDOT C402 Bridge Rail after Test No. 469468-1-3.

obtainable (vehicle obscured view), and maximum permanent deformation was so slight as to be unmeasurable.

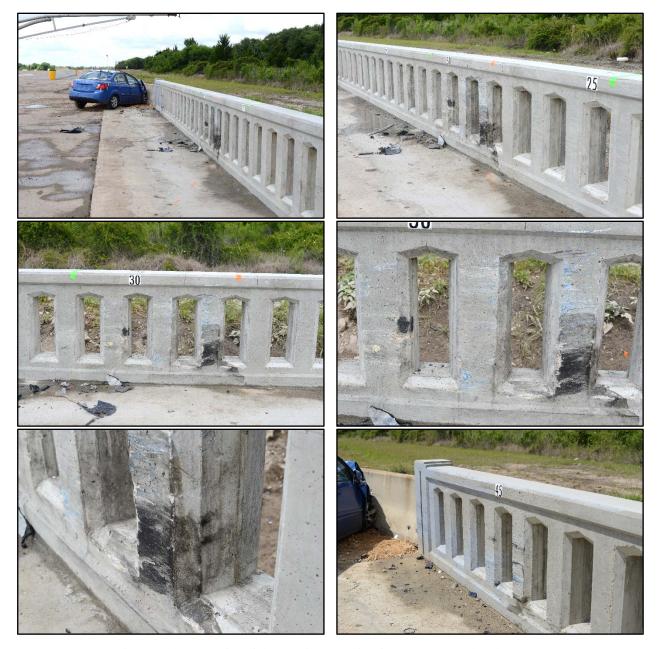
Figure 4.6. TxDOT C411 Bridge Rail after Test No. 469468-3-1.

Figure 4.6 shows the damage to the TxDOT C411 bridge rail. The bridge rail received mostly cosmetic damage in the form of scrapes and tire marks from post 28 through post 31. Working width was 12.0 inches (the width of the barrier), and the height of maximum working width was 42.0 inches (the height of the barrier). No measurable dynamic deflection or permanent deformation occurred.

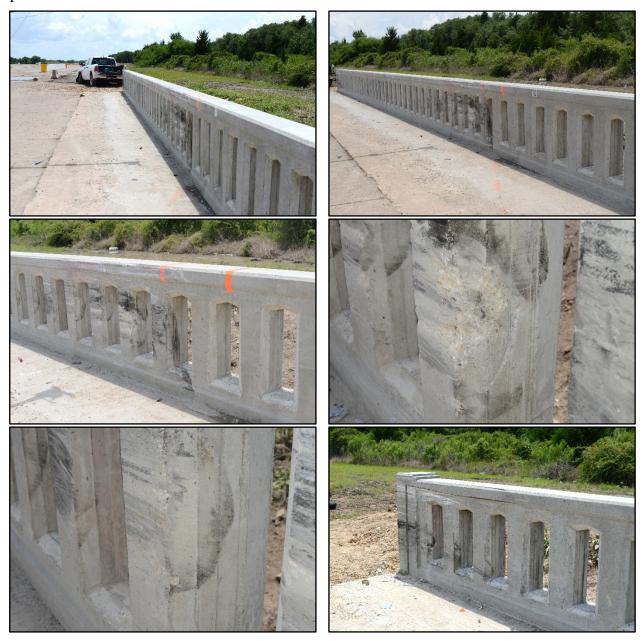
Figure 4.12. TxDOT C411 Bridge Rail after Test No. 469468-3-2.

width was 42.0 inches (the height of the barrier). No measurable dynamic deflection or permanent deformation occurred.

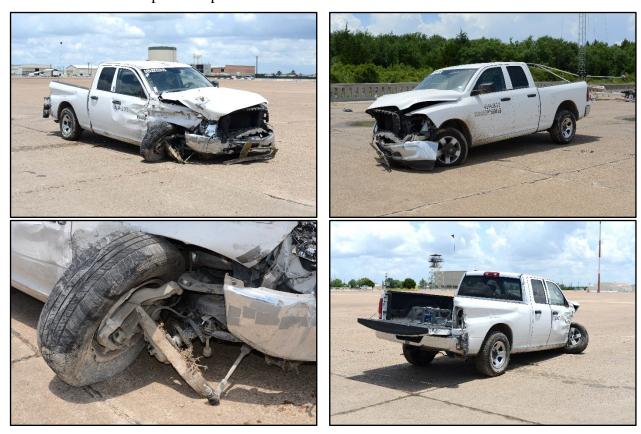
Figure 4.13. Test Vehicle after Test No. 469468-3-2.

height. Maximum occupant compartment deformation was 4.0 inches in the firewall area. Figure 4.14 shows the interior of the vehicle. Tables C.6 and C.7 in Appendix C.4.1 provide exterior crush and occupant compartment measurements.

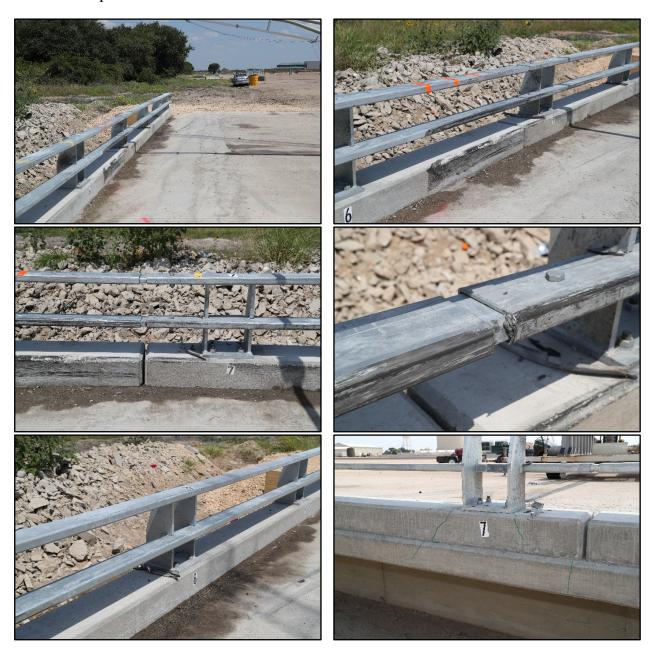
Figure 5.6. TxDOT T1W Bridge Rail after Test No. 469468-4-1.

maximum working width was 25.0 inches. Maximum dynamic deflection was 1.1 inches, and there was no permanent deformation.

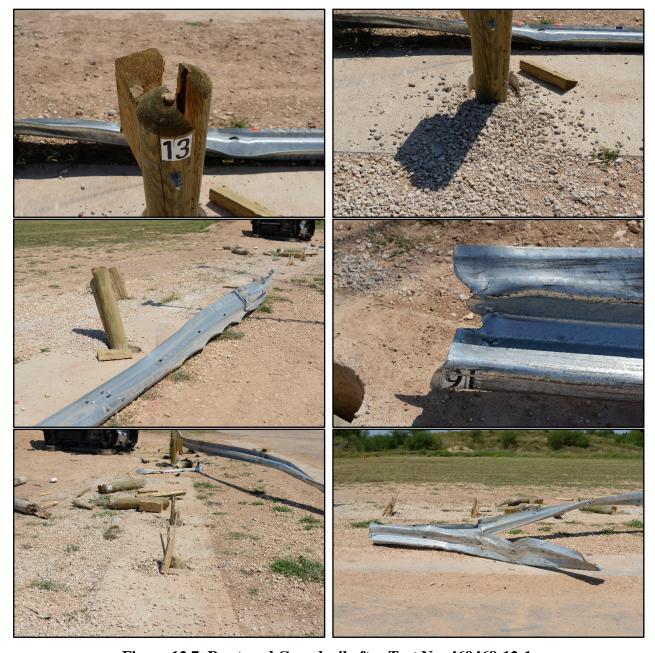
Figure 12.7. Ruptured Guardrail after Test No. 469468-12-1.
