MASH EVALUATION OF TXDOT ROADSIDE SAFETY FEATURES —PHASE II

Test Report 0-6946-R2

TEXAS A&M TRANSPORTATION INSTITUTE COLLEGE STATION, TEXAS

TEXAS DEPARTMENT OF TRANSPORTATION

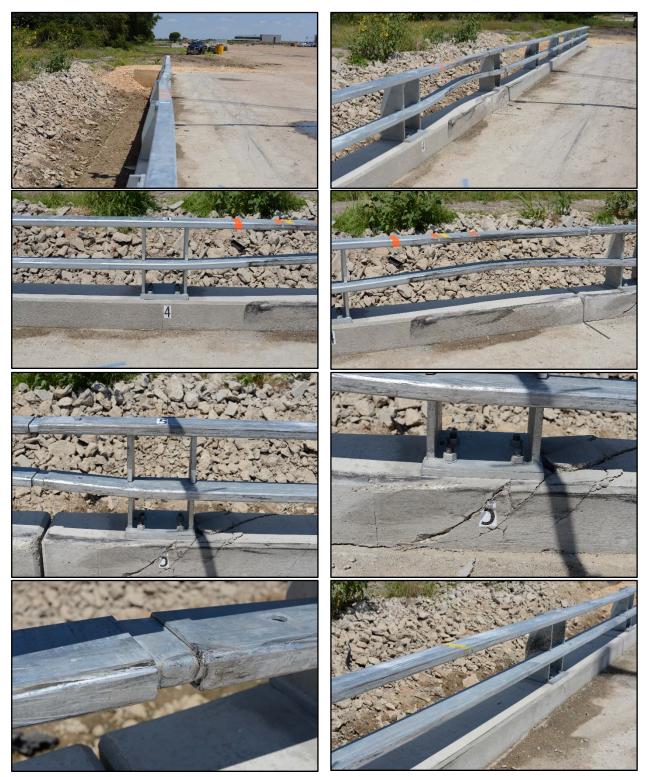
Figure 5.12. TxDOT T1W Bridge Rail after Test No. 469468-4-2.

Figures 5.12 and 5.13 show the damage to the TxDOT T1W bridge rail. The curb showed slight cracking at post 4 on the field side. The bottom splice bolt failed at the splice upstream of post 5, and the curb and deck were cracked on the field side. The curb at post 5 was deflected toward the field side 1.0 inch, and the deck was pushed down approximately 0.75 inch from the joint to 2 ft downstream of post 5. The U-bolt on the bottom rail of post 6 failed, but no concrete

damage was observed. Working width was 19.3 inches, and the height of maximum working width was 43.2 inches. Maximum dynamic deflection was 13.0 inches, and maximum permanent deformation was 3.0 inches.

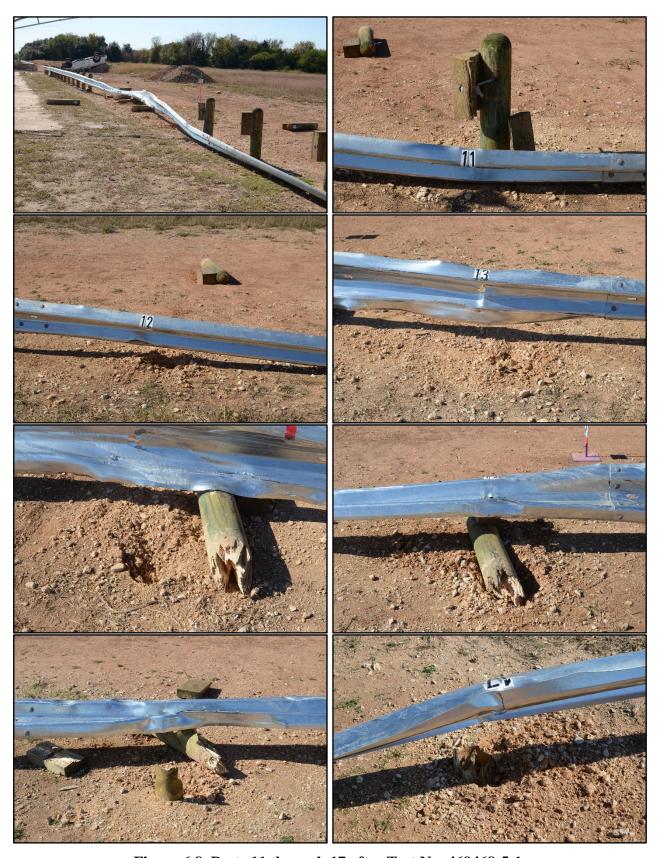
Figure 6.8. Posts 11 through 17 after Test No. 469468-5-1.

Figures 6.6 through 6.9 show damage to the Round Wood Post W-Beam Guardrail. Post 1 was pulled upstream 4.0 inches, and post 2 was pulled upstream 2.6 inches. The W-beam rail element released from posts 1 through 18. Post 11 was pulled upstream and pushed toward field side 0.5 inch. Posts 12 through 17 fractured at ground level. Post 12 with blockout attached was resting 10 ft toward the field side, and post 13 was resting under the rail element. The blockout on post 14 split, and the post was resting 7 ft toward the traffic side. Post 15 and 16 were resting on the field side close to their initial locations, and the blockout of post 16 was split. Post 17 was resting 10 ft downstream and 7 ft toward the field side of its initial position. The soil around post 18 was disturbed, the blockout was split and released from the post, but the post was intact. The vehicle came to rest 11 ft behind the installation. Maximum dynamic deflection during the test was 4.8 ft, and maximum permanent deformation was 3.0 ft.

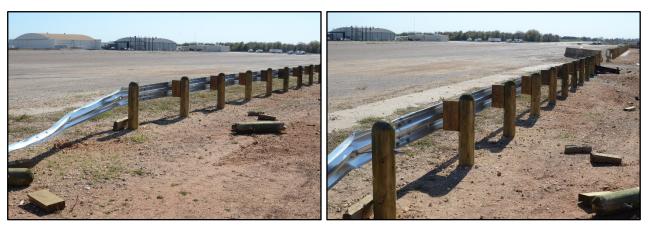
Figure 6.9. Round Wood Post W-Beam Guardrail after Test No. 469468-5-1.

The Round Wood Post W-Beam Guardrail did not contain or redirect the 2270P vehicle. The vehicle overrode the installation. Maximum dynamic deflection prior to override of the installation was 4.8 ft. Post and blockout fragments were present but did not penetrate or show potential for penetrating the occupant compartment, or to present undue hazard to others in the area. Maximum occupant compartment deformation was 5.0 inches in the right front floor pan area. The 2270P vehicle rolled 3.5 revolutions after overriding the installation. Occupant risk factors were within the limits specified in *MASH*.

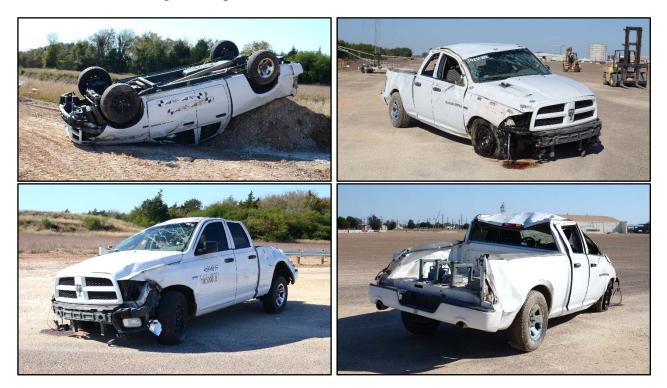
Figure 6.10. Test Vehicle after Test No. 469468-5-1.

Figure 6.10 shows the damage sustained by the vehicle. The front bumper, hood, left and right front fenders, left and right front tires and rims, left and right front and rear doors, left and right exterior bed, rear bumper, roof, and windshield were damaged. Maximum exterior crush to the vehicle was 10.0 inches in the front plane at the right front corner at bumper height. Maximum occupant compartment deformation was 5.0 inches in the right front floor pan. Figure 6.11 shows the interior of the vehicle. Tables E.5 and E.6 in Appendix E.4 provide exterior crush and occupant compartment measurements.

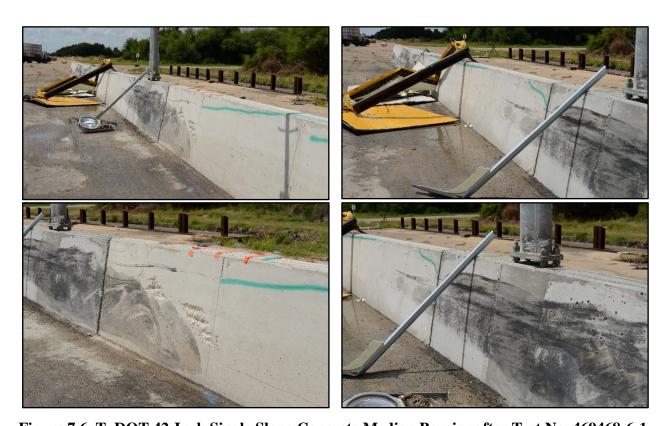
Figure 7.6. TxDOT 42-Inch Single Slope Concrete Median Barrier after Test No. 469468-6-1.

Figure 7.5 shows the damage to the TxDOT 42-inch Single Slope Concrete Median Barrier with Light Pole. The barrier had gouge marks in the impact area, but there were no cracks or other damage observed. The light pole remained upright and intact with some marring around the base. The light fixtures disconnected from the luminaire arms and fell to the ground on each side of the barrier. The concrete around the upstream field side anchor bolt spalled off. Working width was 80.5 inches, and the height of maximum working width was 130.0 inches. Maximum dynamic deflection was not obtainable due to the vehicle obstructing the view of the barrier. There was no measurable permanent deformation.

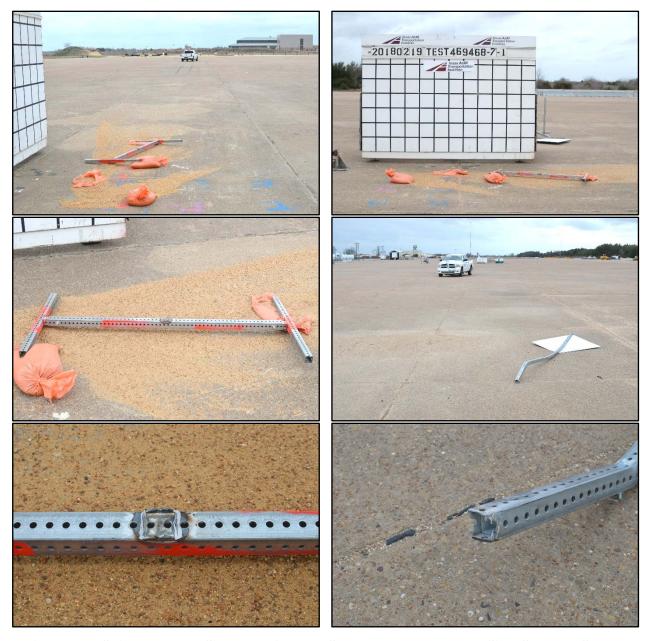
Figure 8.5. Skid-Mounted Single Perforated Steel Tube Temporary Sign Support System after Test No. 469468-7-1.

Figure 8.5 shows the damage to the skid-mounted single perforated steel tube temporary sign support system. The vertical sleeve broke away from the skid at the welds, and the skid assembly was resting 5 ft downstream of the impact location. The sign panel remained attached to the upright support and sleeve and came to rest 377 ft downstream from the impact location. Two sandbags remained intact, and two were damaged. Sand was scattered in the impact area.

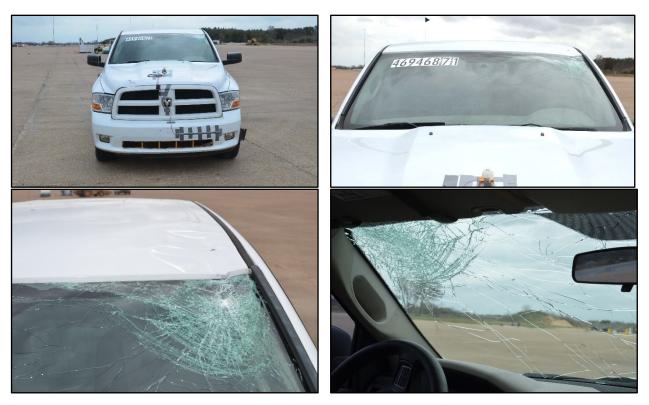
Figure 8.6. Test Vehicle after Test No. 469468-7-1.

Figure 8.6 shows the damage sustained by the vehicle. A very small depression in the left side of the bumper and hood were observed. The windshield was cracked at the upper left corner over an area measuring 12 inches × 14 inches, and the edge of the roof just above this location was slightly dented and scraped over an area measuring 7 inches × 8 inches. The windshield also had a slight indentation (that was so slight as to be unmeasurable) 18 inches to the left of centerline. No hole or tear was observed in the windshield. Maximum exterior crush to the vehicle was so slight as to be unmeasurable. No occupant compartment deformation or intrusion was observed. Figure 7.7 shows the interior of the vehicle. Tables G.3 and G.4 in Appendix G.1.1 provide exterior crush and occupant compartment measurements.

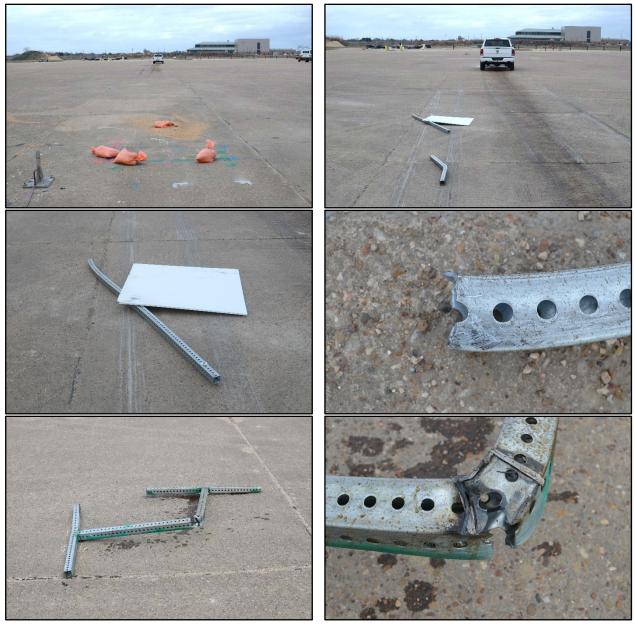
Figure 8.11. Skid-Mounted Single Perforated Steel Tube Temporary Sign Support System after Test No. 469468-7-2.

Figure 8.11 shows the damage to the skid-mounted single perforated steel tube temporary sign support system. The vertical sleeve broke away from the skid at the welds, and the skid was resting 348 ft downstream and 2 ft left of the point of impact. The sign panel remained attached (by one bolt) to a 7 ft long piece of the upright support and came to rest 160 ft downstream and 5 ft left of the impact location. A 4 ft long fractured piece of upright support and vertical sleeve came to rest 150 ft downstream and 1 ft left of the impact location. Three sandbags remained intact, and one was damaged with a small amount of sand scattered in the impact area.

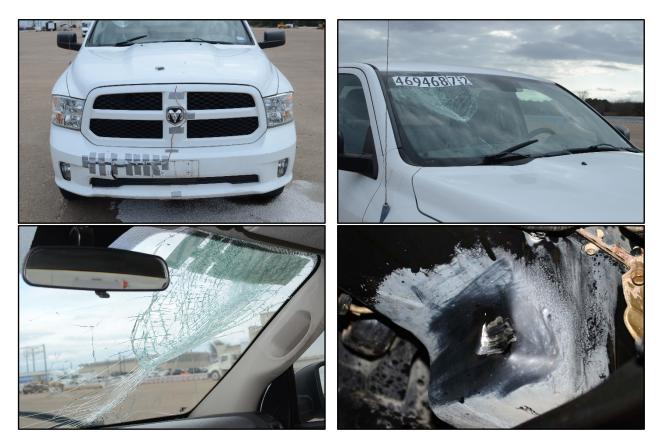
Figure 8.12. Test Vehicle after Test No. 469468-7-2.

Figure 8.12 shows the damage sustained by the vehicle. A very small depression in the right side of the bumper and front of the hood was observed. The hood also had a small indentation at the right rear near the windshield over an area measuring 10 inches \times 6 inches. The upper right corner of the windshield was cracked over an area measuring 18 inches \times 16 inches. The maximum deformation of the windshield was 2.0 inches. No holes or tears occurred in the windshield. The windshield also had a slight indentation (that was so slight as to be unmeasurable) 18 inches to the right of centerline. The rear right side of the roof sustained scuff

marks. A 2-inch \times 2-inch indentation and a small cut in the oil pan were observed. Maximum exterior crush to the vehicle was so slight as to be unmeasurable. No occupant compartment deformation or intrusion was noted other than the deformation of the windshield described above. Figure 7.13 shows the interior of the vehicle. Tables G.7 and G.8 in Appendix G.2.1 provide exterior crush and occupant compartment measurements.

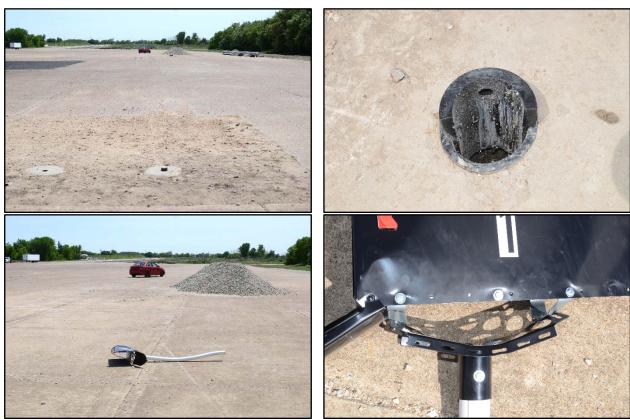
Figure 9.6. Single Mailbox with Recycled Rubber Support Post in Type 4 Foundation after Test No. 469468-8-1.

Figure 9.6 shows damage to the mailbox system. The mailbox remained attached to the support post, and the assembly came to rest 239 ft downstream from the point of impact and 15 ft to the right of centerline of the vehicle path. The lid detached from the mailbox and was came to rest 71 ft downstream from the point of impact and 12 ft to the right of centerline of the vehicle path. The wedge remained in the socket.

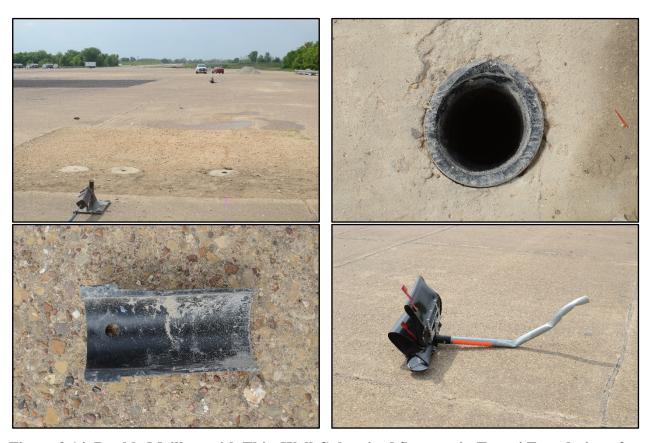
Figure 9.14 shows damage to the mailbox system. The support with the mailboxes attached came to rest 120 ft downstream from impact. The wedge remained near the test site. The lid detached from one of the mailboxes and came to rest 34 ft downstream from the point of impact.

Figure 9.14. Double Mailbox with Thin-Wall Galvanized Support in Type 4 Foundation after Test No. 469468-8-2.

The thin-wall galvanized support pipe yielded to the vehicle, deformed about the front end, and pulled out of its socket. The support and mailboxes were carried forward by the vehicle and remained attached as a system. No windshield contact was observed.

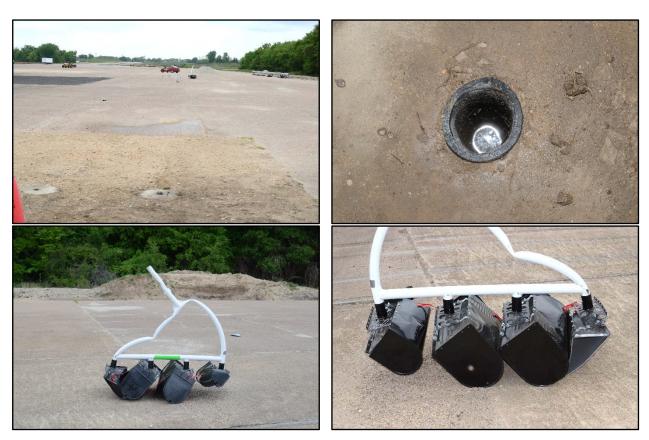
Figure 9.22 shows damage to the mailbox system. The support with the mailboxes attached came to rest 160 ft downstream from impact and 10 ft to the right of centerline. The lid and rear of the mailbox on the impact side detached. The wedge remained near the impact location.

Figure 9.22. Multiple Mailboxes with Multi-Hanger Support in Type 4 Foundation after Test No. 469468-8-3.

The support deformed around the front of the vehicle and pulled out of the ground socket. The released mailbox system rotated into the windshield and subsequently up and over the vehicle. The windshield sustained deformation of 1.8 inches, below the 3-inch maximum for *MASH*, and there were no tears or holes through the windshield.

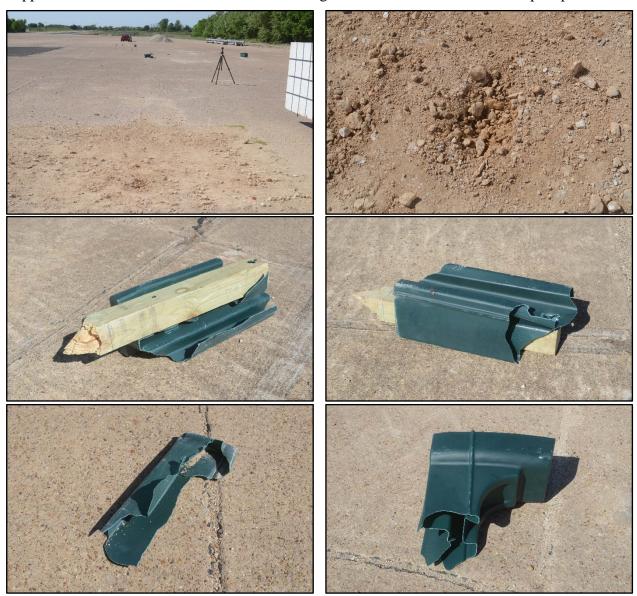
Figure 9.30 shows damage to the support and mailbox. The wood support post fractured slightly below ground, and the support post and mailbox fractured into several pieces. The base of the mailbox was resting 51 ft downstream from impact and 30 ft to the right of centerline of the vehicle impact path. The top of the support post came to rest 83 ft downstream from impact and 2 ft to the right of centerline. The mailbox was resting 97 ft downstream and 30 ft to the right of centerline. A fractured piece of support post and the bottom of the base of the mailbox support came to rest 159 ft downstream and along the centerline of the vehicle impact path.

Figure 9.30. Single Molded Plastic Mailmaster® Mailbox with Wood Support in Type 5 Foundation after Test No. 469468-8-4.

The 4×4 wood support post fractured slightly below grade. The molded plastic mailbox system separated and fractured into several pieces. The separated upper section of the plastic mailbox system contacted the windshield. Maximum deformation of the windshield was 1.9 inches, and there were no tears or holes through the windshield.

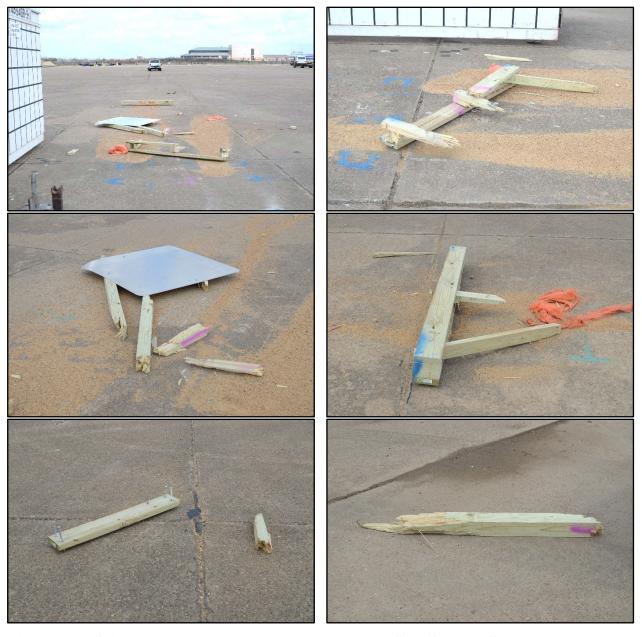
Figure 10.5 shows the damage to the skid-mounted dual wood post temporary sign support system. The system fractured into several pieces. Part of the base was resting 3.5 ft downstream and another section was resting 30 ft downstream. The sign panel with sections of the support posts was resting 15 ft downstream of impact. Several smaller pieces of the base were resting 150 ft downstream and 6 ft to the left of impact and 225 ft downstream and 27 ft right of impact.

Figure 10.5. Skid-Mounted Dual Wood Post Temporary Sign Support System after Test No. 469468-9-1.

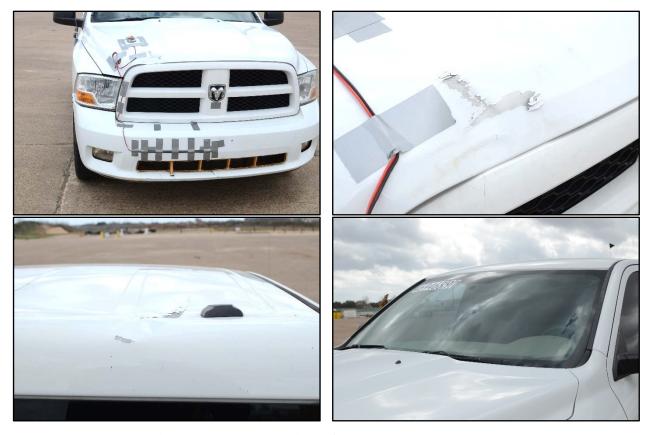
Figure 10.6 shows the damage sustained by the vehicle. The right side front bumper and right side hood had small dents. The rear right side of the roof sustained a 10-inch long \times 6-inch dent. Maximum exterior crush to the vehicle was 1.0 inch on the rear roof. No occupant compartment deformation or intrusion was observed. Tables I.3 and I.4 in Appendix I.1 provide exterior crush and occupant compartment measurements.

Figure 10.6. Test Vehicle after Test No. 469468-9-1.

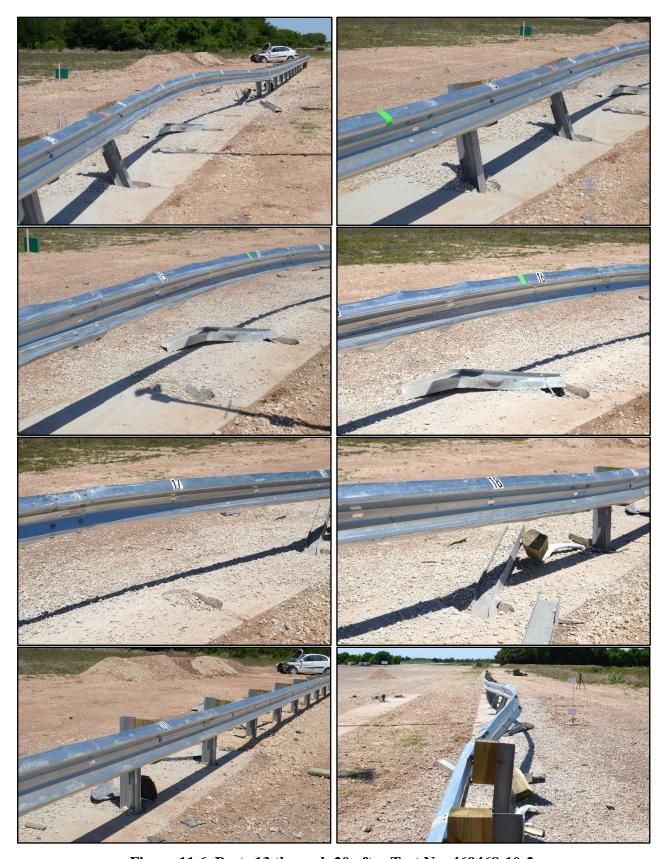
Figure 11.6 shows damage to the MBGF with steel posts in rocky terrain. The soil around post 1 was disturbed, and no movement was observed at posts 2 through 7. The soil around posts 8 and 9 was disturbed and the blockouts were cracked. Posts 10 through 14 were leaning toward field side at 87°, 85°, 81°, 75°, and 65°, respectively. The rail separated from posts 14 through 18, and the blockouts separated from posts 14 and 18. Posts 15 through 17 were pulled from their holes. Post 17 was resting 2.5 ft toward traffic lanes, post 15 was resting 2.5 ft toward the field side, and the rest of the pulled out posts were resting near the rail. Post 18 was leaning 16° downstream and 80° toward the field side. Posts 19, 20 and 21 were leaning 83°, 86°, and 88° toward field side, respectively. Post 22 was leaning 88° upstream and toward the field side and rotated slightly clockwise. Posts 23 through 25 were leaning upstream and toward the field side 88°, and the blockouts were twisted on the post. Posts 26 through 30 were leaning upstream 88°. Working width was 75.9 inches, and height of working width was 39.5 inches. Maximum dynamic deflection during the test was 40.5 inches, and maximum permanent deformation was 21.0 inches.

Figure 11.6. Posts 13 through 20 after Test No. 469468-10-2.

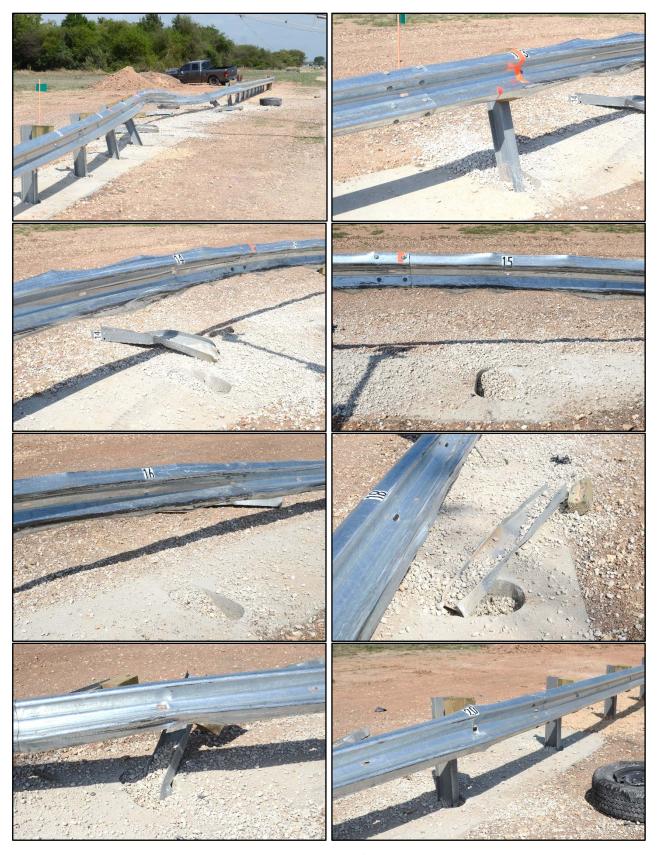
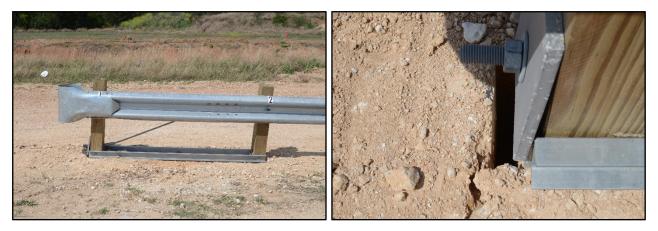
Figures 11.12 and 11.13 show damage to the MBGF in rocky terrain. Post 1 was pulled upstream 1.75 inches, and post 2 was pulled upstream 0.75 inch. The W-beam rail element released from posts 3 through 10 and 14 through 20. Posts 10 and 11 were pulled slightly downstream and pushed toward the field side. Post 12 was leaning 85° downstream and 76° toward the field side. Post 13 was leaning 84° downstream and 65° toward field side. Posts 14 through 18 pulled out of their holes and released from the rail element. Post 14 was resting 10 inches downstream and 3 ft toward the field side. Post 15 was resting 11.5 ft downstream and 5 ft toward the field side. Post 16 was resting 18 ft downstream and 5 ft toward the field side. Post 17 was resting 21 ft downstream and 6.5 ft toward the field side. Post 18 dislodged from the ground but remained adjacent to the guardrail. Post 19 was leaning 34° from horizontal. Post 20 was leaning 83° downstream and 82° toward the field side. Posts 21 through 30 were intact. The soil around posts 29 and 30 was disturbed. Working width was 76.2 inches, and height of working width was 11 inches. Maximum dynamic deflection during the test was 74.8 inches, and maximum permanent deformation was 41 inches.

Figure 11.12. Posts 13 through 20 after Test No. 469468-10-1.

Figure 11.13. Upstream Terminal after Test No. 469468-10-1.

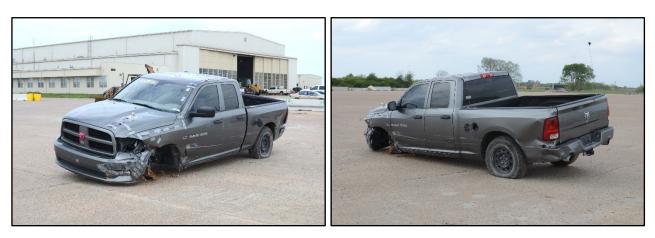
Figure 11.14 shows the damage sustained by the vehicle. The front bumper, hood, grill, left front fender, left front tire and rim, left upper and lower ball joints, left front and rear doors, left exterior bed, and rear bumper were damaged. Maximum exterior crush to the vehicle was 7.0 inches in the front and side plane at the left front corner at bumper height. No occupant compartment deformation or intrusion occurred. Figure 11.15 shows the interior of the vehicle. Tables J.9 and J.10 in Appendix J.4.2 provide exterior crush and occupant compartment measurements.

Figure 11.14. Test Vehicle after Test No. 469468-10-1.

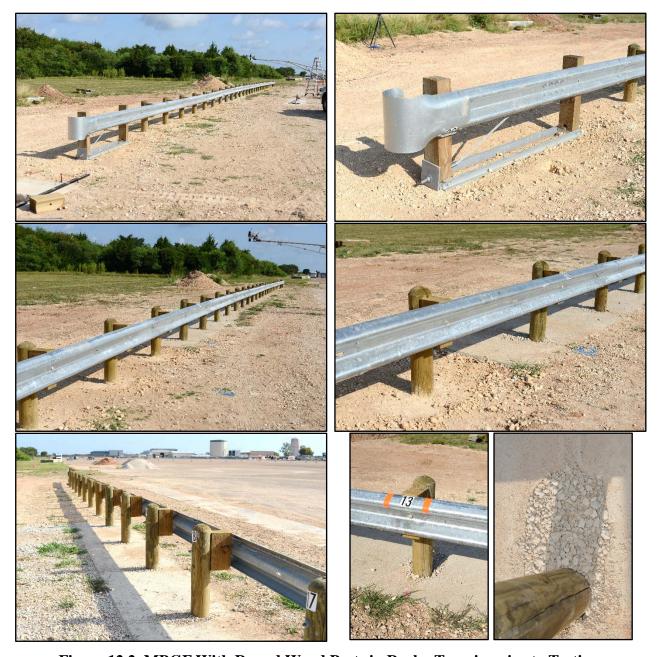
Figure 12.2. MBGF With Round Wood Posts in Rocky Terrain prior to Testing.
